The Conversion of Traditional Farm Buildings:
A guide to good practice

This guidance provides more detailed advice by English Heritage on good practice in conversion projects for owners, designers, local authority conservation officers and others involved in projects of this type. An appendix is included which provides a decision-making framework to help inform options for sustainable reuse.

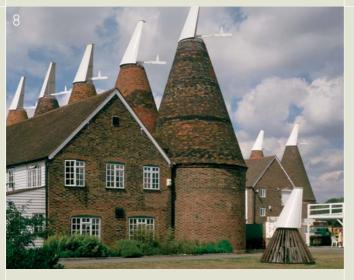
- **8** Massed oast houses at Whitbread Hop Farm, Paddock Wood, Kent. © *English Heritage*
- **9** A field barn in the Yorkshire dales which has recently been repaired. © *English Heritage*
- 10 An 18th-century granary in West Sussex with staddle stones and tarred weatherboarding. © Daniel Eugenio LRPS Images of England
- II A fine early 16th-century barn in Suffolk with stables at one end.

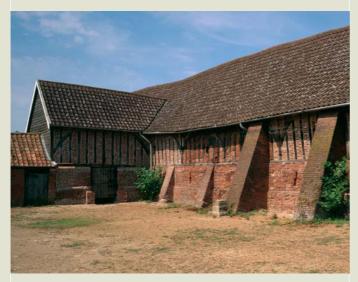
© Mike Williams/ English Heritage
- 12 A reconstruction of flail threshing viewed through a typical cart door entrance with porch canopy and threshold. © English Heritage (RCHME)

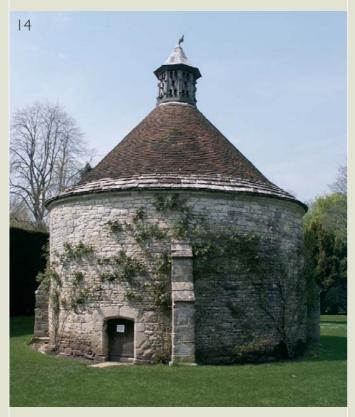
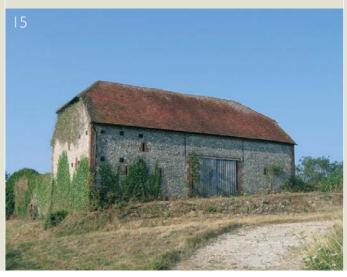
16, 17, 18 As much as possible about the way the building is constructed and its condition should be understood before significant works of repair/alteration are undertaken. Loss of historic fabric should be minimised and repairs should be carried out using appropriate materials. 16 © English Heritage 17 © English Heritage 18 © Spratley and Woodfield Architects

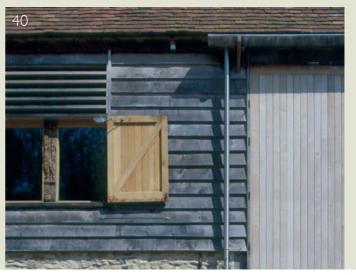
- This cart door entrance has been carefully designed with a mixture of solid and void. © *Van der Steen Hall Architects*
- Threshing doors should be retained where these still exist. Their retention helps to reduce the impact of a new glazed screen. © Bob Edwards

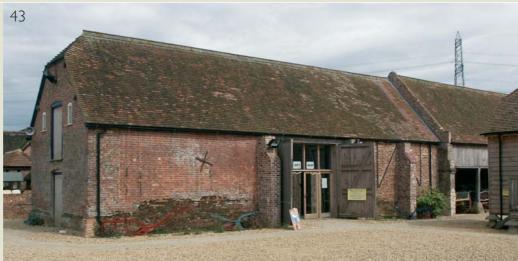
- A wicket entrance has been incorporated into fully boarded doors within the cart door entrance. © *English Heritage*
- **48, 49** Openings high in gable walls of framed structures can be an effective way of introducing light without significantly altering the character of the building's external appearance. **48** © *Huw Thomas* **49** © *Rolf Richardson Images of England*
